Application of ground penetrating radar for evaluating foundation structure condition after earthquake

Abstract: At the time of seismic activity, the failure of the foundation structure will lead to building damage. When the West Pasaman 2022 earthquake occurred, PT. XYZ is constructing a feed mill tower. Since strong earthquake shocks were felt at the project location, foundation structure evaluation is needed to ensure the safety of the building. Ground Penetrating Radar (GPR) is a tool that is widely used to detect subsurface conditions. This study used GPR as a non-destructive testing technique to evaluate the condition of the foundation structure. The building evaluated is a high-rise steel building, using spun pile foundation. GPR test was carried out in specified lanes, with measurement tracks set at 10 lanes. Any cracks or fractures on the foundation will be indicated by the interruption of waves at the point of the crack or fracture. The GPR test results from readings of electromagnetic wave propagation showed that waves can reach the end of each foundation tested, ranging from 17.10 m to 17.82 m deep. It means that there are no cracks or fractures found on the slab, pile

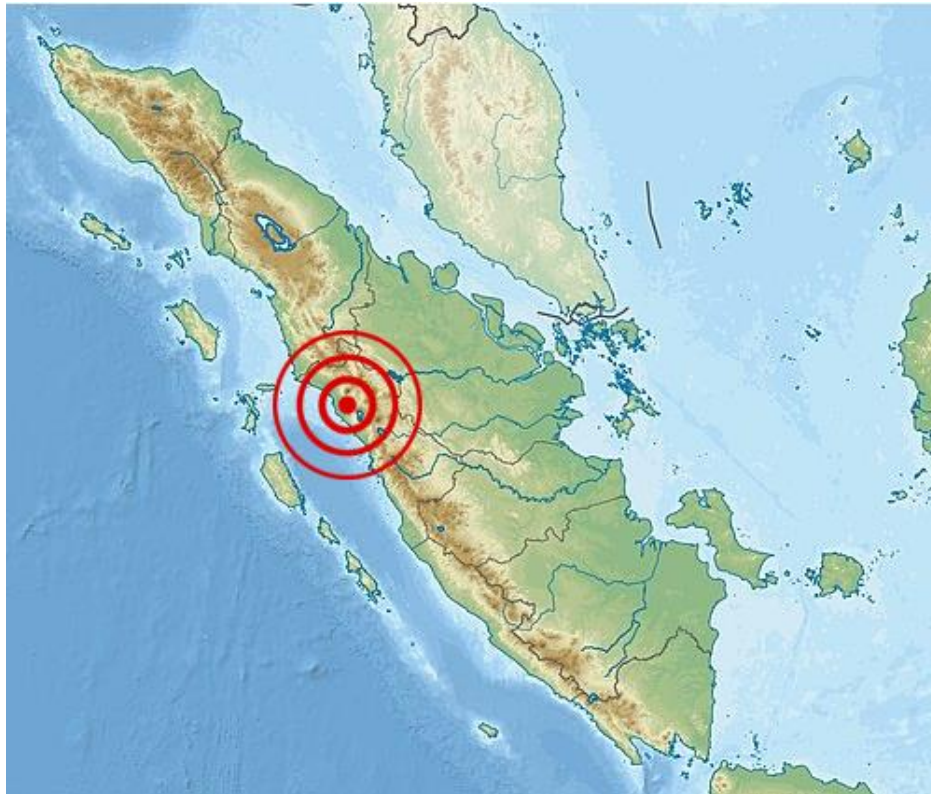
Figure 3. West Pasaman earthquake epicenter point

The latest strong earthquake in this province occurred on February 25, 2022, at 08:39 Indonesian Western Time, with a magnitude of 6.1 on the Richter scale. The epicenter of the earthquake is located in West Pasaman Regency, as shown in Figure 3. This earthquake is a shallow crustal earthquake triggered by active fault activity, i.e. Semangko Fault, in the uncharted Talamau segment precisely [17]. The analysis of the source mechanism shows that this earthquake had a horizontal movement mechanism [18].

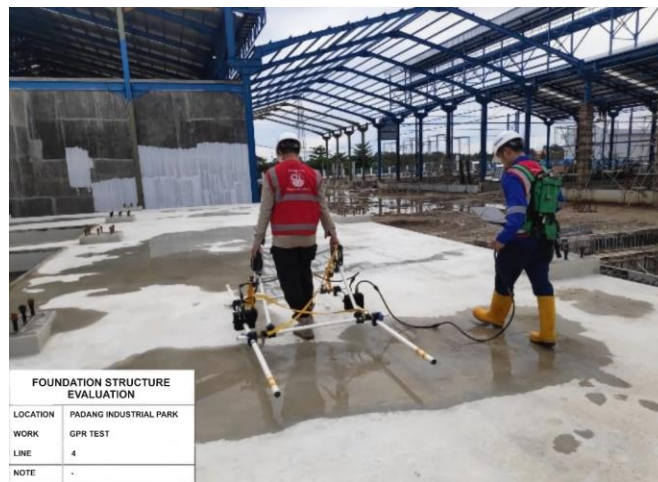
The GPR equipment used in this study is the IDS RIS-ONE GPR with antenna TR 40 MHz manufactured by the IDS GeoRadar, as shown in Figure 5.

Figure 5. IDS RIS-ONE GPR equipment

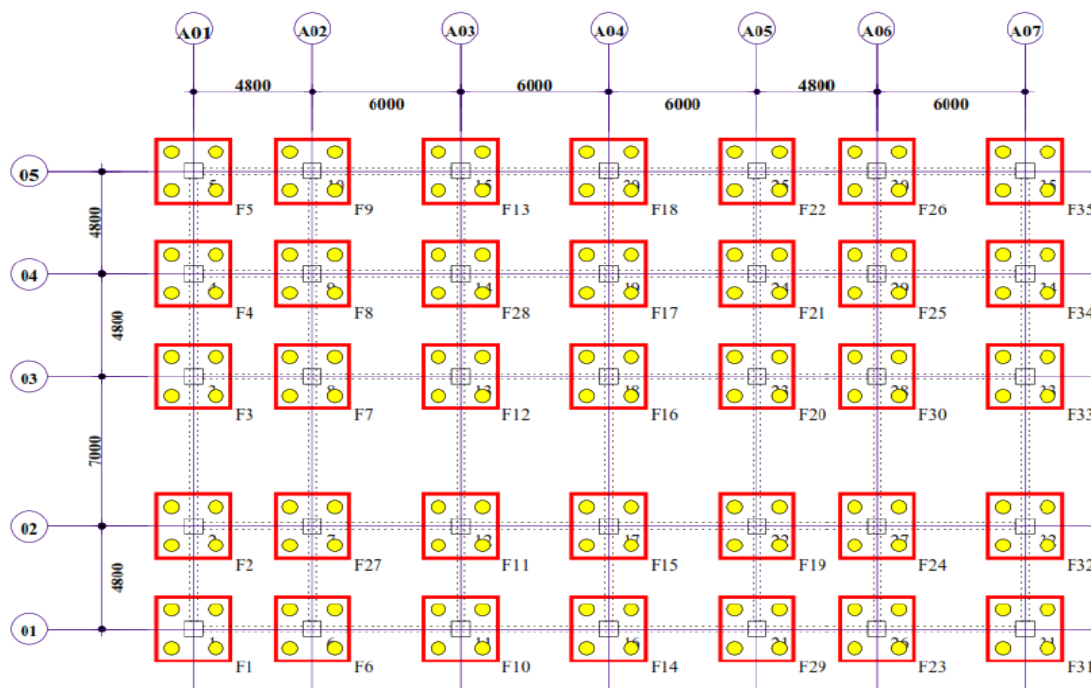
The object of this research is a feed mill tower building with steel frame construction as the upper structure. This building uses a deep foundation type for the substructure, i.e. spun pile foundation. The diameter of spun piles is 600 mm, designed with a depth range between 16-19 m. The thickness of the pile cap is 1 m, while the thickness of the slab is 20 cm. The layout of the foundation as the research object to be analyzed and tested by using GPR is shown in Figure 7, and the upper structure modeling can be seen in Figure 8.

Figure 7. Foundation layout plan

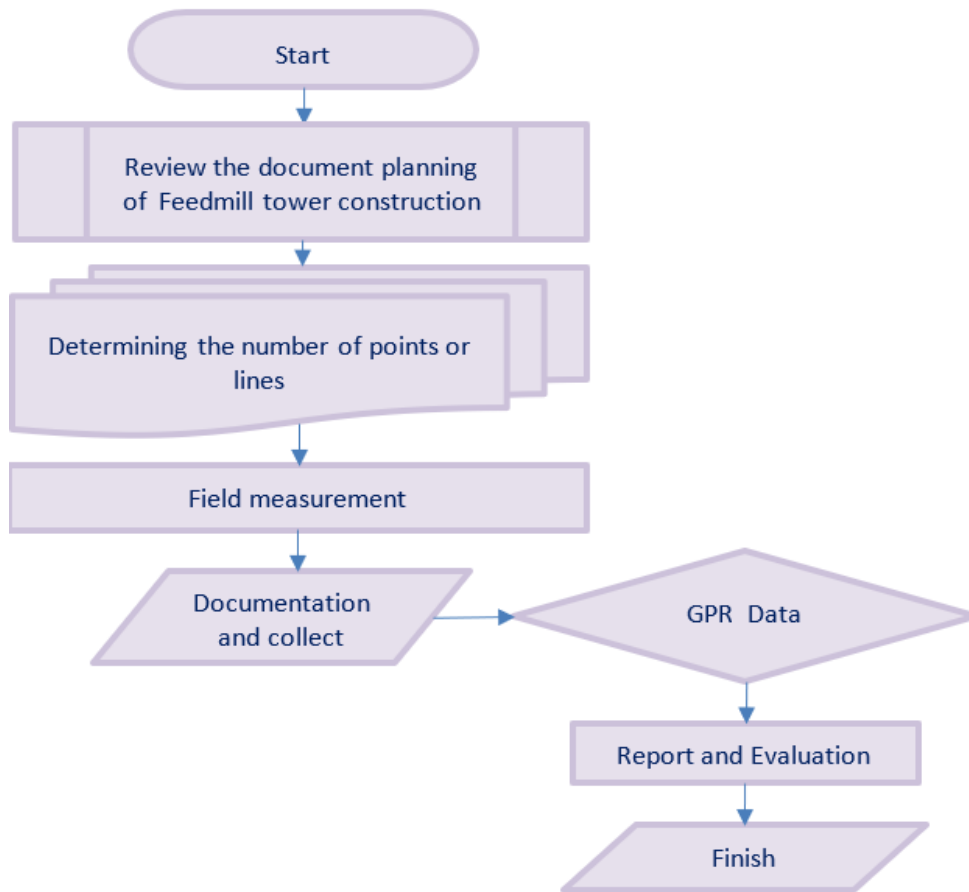
After field data acquisition, raw radar data is processed and analyzed. Georadar data processing using the Reflex-w software aims to amplify the diffraction signal recorded on the georadar data so that it can be more easily interpreted. In addition, data processing is carried out to remove noise recorded in the radar data during measurements. This aims to avoid misinterpretation of the radar program. After processing the data, the next step is to interpret the radar data to obtain the position and depth of the foundation structure. The analysis was carried out based on the study objectives to evaluate the condition of the foundation structure after an earthquake, and then compare it with the PIT results to gain more reliable conclusions. If the detected foundation depth is still within the range of design depth range, and there are no cracks or fractures in the slab, pile cap, or spun pile detected, it means the foundation is still in good condition [34], [35]. Investigation stages are depicted in Figure 9.

Figure 9. GPR testing and analysis stages

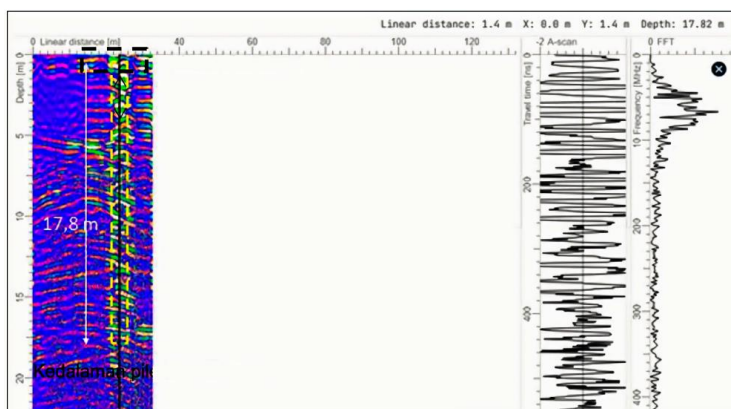
Figure 12. Track 2 – Lane 19

On Track 2, the detected depth of the foundation is 17.82 m, the thickness of the slab is 20 cm, and the thickness of the pile cap is 1 m.

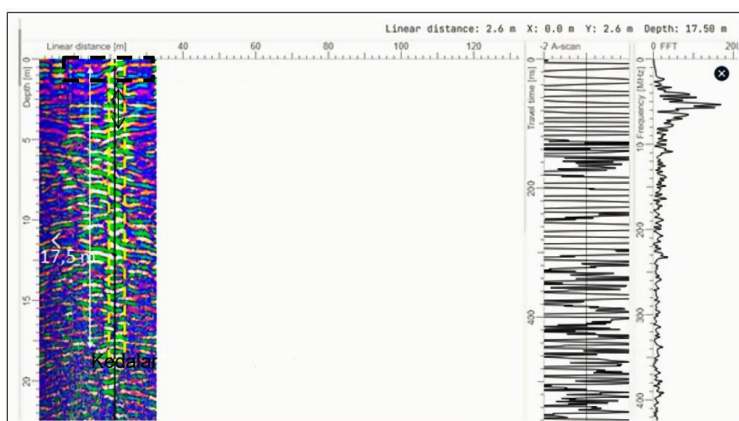
Figure 13. Track 3 – Lane 18

On Track 3, the detected depth of the foundation is 17.58 m, the thickness of the slab is 20 cm, and the thickness of the pile cap is 1 m.

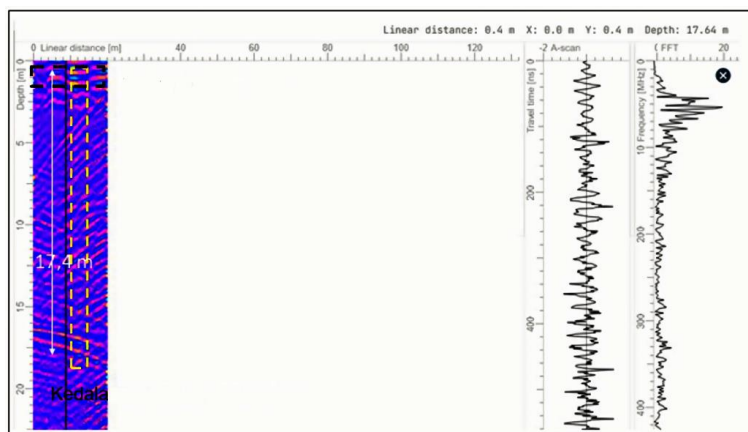
Figure 14. Track 4 – Lane Dg

On Track 4 the detected depth of the foundation is 17.64 m, the thickness of the slab is 20 cm, and the thickness of the pile cap is 1 m.

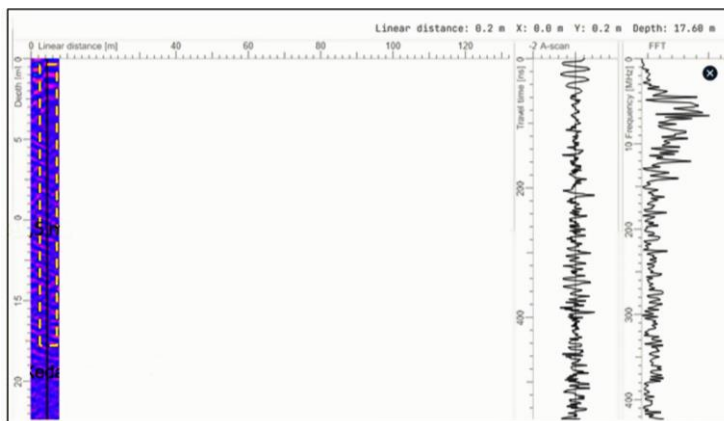
Figure 17. Track 7 – Lane D

On Track 7, the detected depth of the foundation is 17.68 m, the thickness of the slab is 20 cm, and the thickness of the pile cap is 1 m.

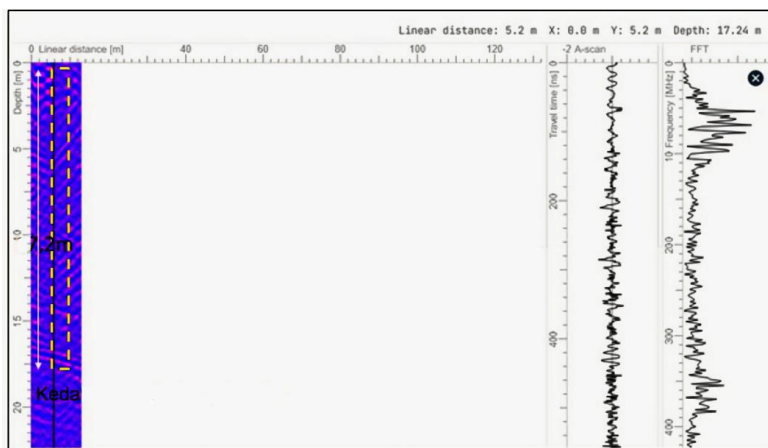
Figure 19. Track 9 – Lane Df

On Track 9, the detected depth of the foundation is 17.24 m, the thickness of the slab is 20 cm, and the thickness of the pile cap is 1 m.

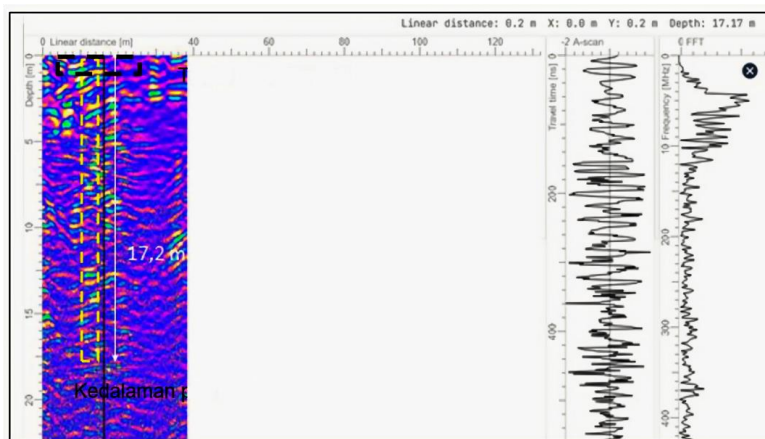
Figure 20. Track 10 – Lane 17

On Track 10, the detected depth of the foundation is 17.17 m, the thickness of the slab is 20 cm, and the thickness of the pile cap is 1 m.
