Porosity Defect Analysis in ST 37 Steel Welding Joints Using the Dye Penetrant Method

ABSTRACT

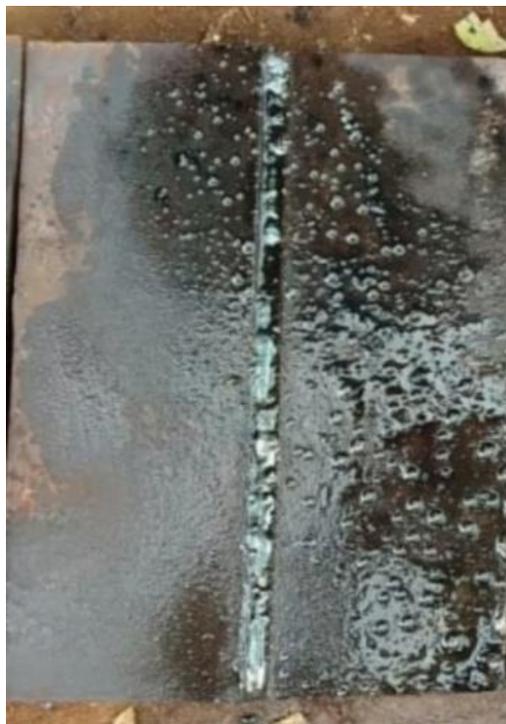
Figure 1 : Welding Results of 1G Contaminated with Dirt

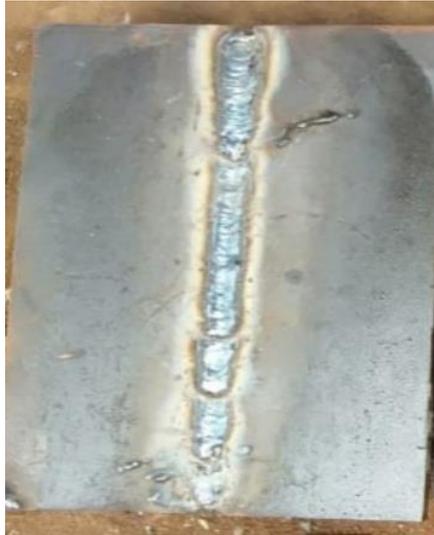
Figure 2 : Welding Results of 1G Contaminated with Dirt

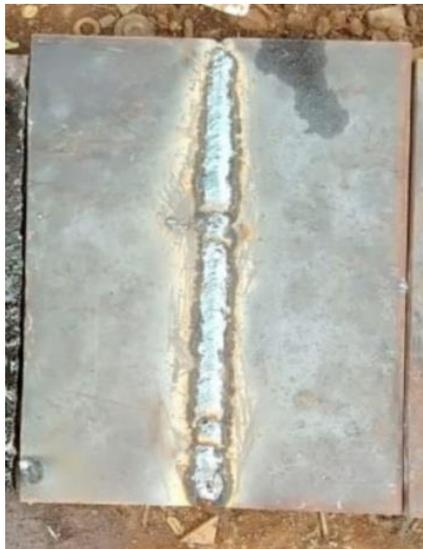
Figure 3 : Welding Results of 1G Contaminated with Dirt

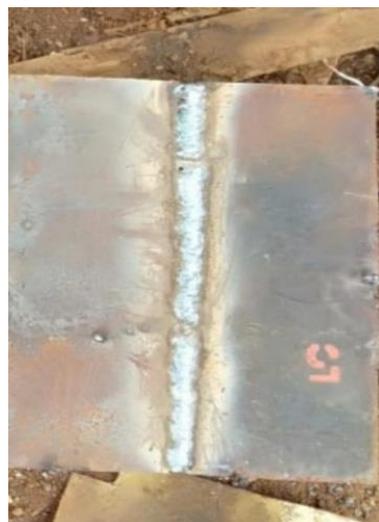
Figure 4 : Welding Results of 1G Contaminated with Dirt

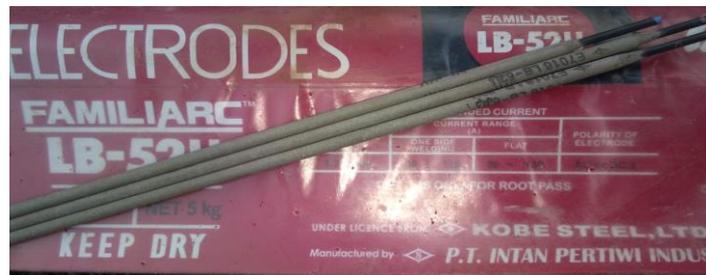
The electrodes used were E-7016 (LB 52U) with a diameter of 2.6mm and a diameter of 3.2mm for fillers and capping.

Figure 5 : Electrodes

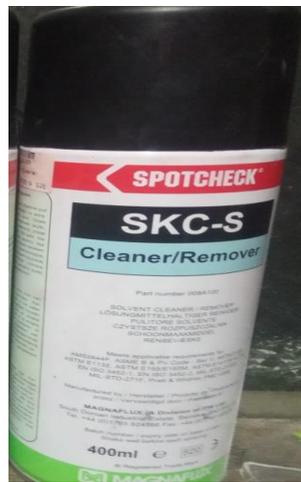
Figure 6 : Cleaner / Remover

Cleaner functions as a cleaning process on the object to be tested, this process is a cleaner remover sprayed on the test object so that there are no indications of dirt such as oil, rust, or other impurities.

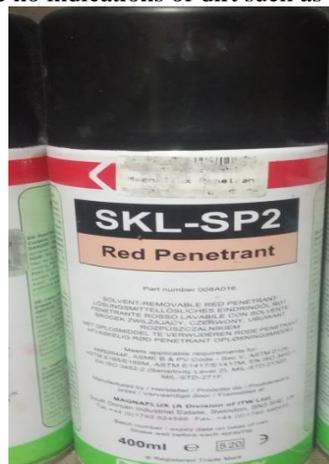
Figure 7 : Red Penetrant

This red penetrant functions as a liquid that will seep into the defective pores of the material that occurs for this red penetrant fluid takes 5 to 10 minutes to soak properly into the pores of the defective pores.

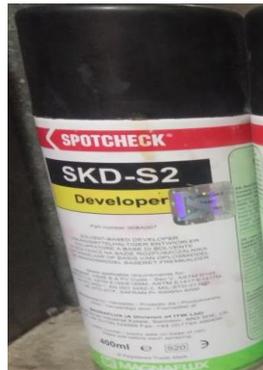
Figure 8 : Developer

The developer is a liquid that will release red penetrant fluid that has seeped into the pores of the defect that occurs or the developer fluid serves as the development fluid to see the indication of defects that occur clearly.

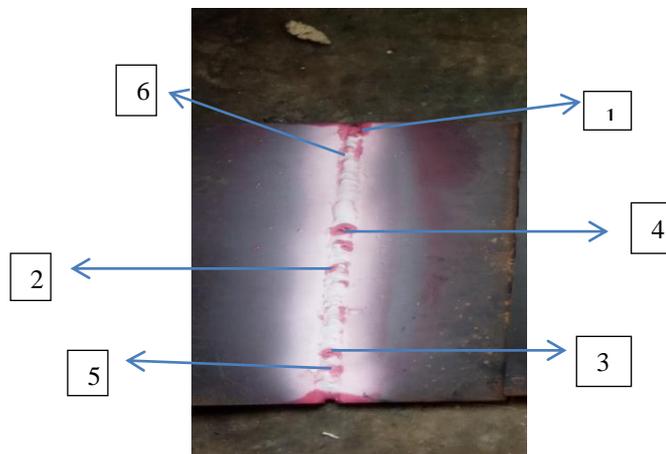
Figure 9 : Welding Inspection Results Using Dye Penetrant.

The results of the non-destructive test dye penetrant against welding SMAW Kampung V contaminated with paint, oil, oil, etc., can be seen in figure (9) namely the defects that occur in the form of porosity, the amount of porosity that occurs in figure 6 defects that occur in the form porosity. The first defect occurs porosity cluster with a size of 8mm defect, the defect result is declared rejected because it exceeds the predetermined standard, the second defect that occurs porosity with a porosity defect size 5mm, the result of this defect can be declared rejected because it exceeds the specified standard limits. Defect number 3 is still a porosity defect with a defect size of 2mm, the defect that occurred is still declared acceptable because it is still within the standard limits. Furthermore, defects that occur in the designated image number 4 in the form of porosity defects and number 5 defects that occur 5mm defects that occur are porosity, for size defects that occur in number 4 declared accepted and 5 declared rejected, then the defects that occur in with the appointment number 6 defects that occur are porosity with a size of 2mm defects, these defects are also still in the standard limits and are declared accepted.

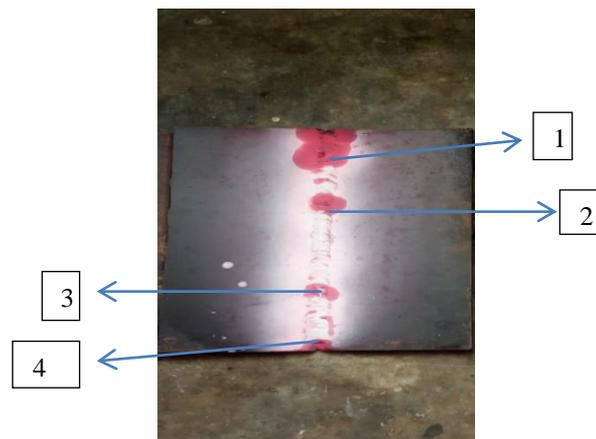
Figure 10 : Welding Inspection Results Using Dye Penetrant.

Figure (10) is also the result of welding SMAW Kampung V that is contaminated with dirt and so on, carried out by dye penetrant testing, can be seen directly, namely the development of red penetrant fluid, in that development is a porosity defect that occurs which amounts to 4 porosity defects. The first is a wormholes porosity defect with a 12mm defect size that occurs when this defect is declared rejected. The second is the cluster porosity defect with a defect size of 6mm and this defect is declared rejected. The third is the porosity defect with a defect size of 2mm. This defect is declared accepted, and the last defect has occurred porosity with a defect size of 2.5mm, this defect is still declared accepted. Based on the table above the results of the welding carried out there are defects that occur. The defects that occur according to the standards of The Welding Institute have been rejected because the welding results exceed the predetermined standard limits.

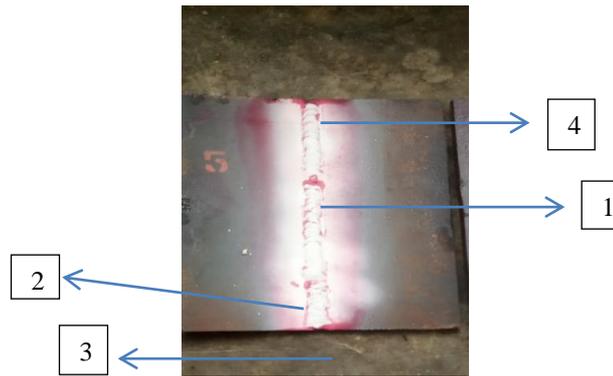
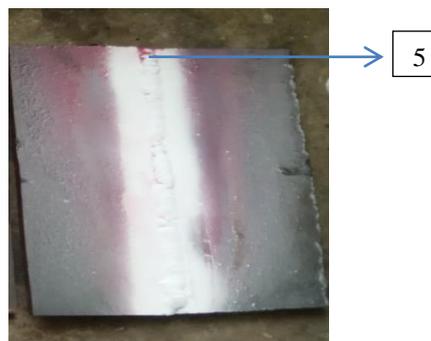
Figure 11 : Welding Inspection Results Using Dye Penetrant.

Figure 12 : Welding Inspection Results Using Dye Penetrant.

Figures (11 and 12) are also the result of welding seam SMAW V that is not contaminated with dirt and so on, the results of welding are done by testing dye penetrant, can be seen directly, namely the development of red penetrant fluid, the development of red penetrant fluid is a defect that happened. Porosity defects that occur in the appointment of numbers 1 and 2, namely porosity defects with a size of 3mm defects, defects that occur are declared accepted because they are still within the standard limits. Furthermore, the defects that occur in tables number 3 to number 5 are still porosity which is the size of the porosity defects that occur 2mm, 1mm, and 2.5mm, the defects that occur are still declared acceptable because they are still within the standard limits. From table 2 above according to the TWI standard dye penetrant testing method that there are indications of defects that occur, based on the standard used defects that occur are still within the criteria accepted even though there are indications of defects that occur.
