The Risk Identification on 3" GL BO3-52520 Process Pipelines Using A Risk-Based Inspection Method

Angga Pratama Putra[1][*], Johny Wahyuadi Soedarsono[1], Azizah Intan Pangesty[1], Mhd. Ibkar Yusran Asfar[1], Aprizal[2] and Romal Ramadhan[3]

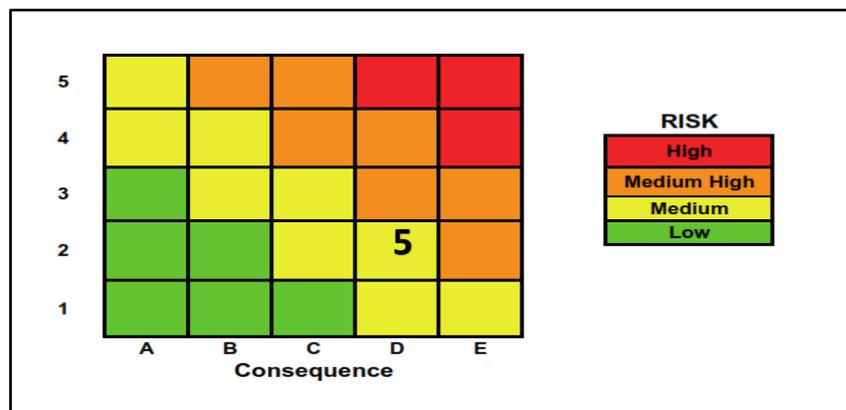
Figure 1: Risk matrix

The approach used to calculate POF and COF results in different risk ratings for each segment. The pipeline segment located in the splash zone carries a Low-risk rating (2). Further investigation revealed that the disparate ratings for the gas pipeline segments resulted from a breakdown mechanism. There is a loss of pipe wall thickness and external corrosion in the splash zone segment. As a result, the consequence of failure is significant (D). We plot the POF and COF values into a 5x5 matrix to determine the existing risk conditions.

According to the RBI method for piping system number 3, GLB03-52520 has a Remaining Life of = RL 9 years, indicating a Low Probability of Failure (PoF) (2) and a Medium-High Rating for Consequences of Failure (CoF) (4) based on the multiplication of standby availability, location, and financial. The consequences of failure are similar for each segment due to the influence of operating data. Corrosion-related environmental effects affect the probability of failure in the spark zone segment [20]. Reduce failure risk by enhancing the effectiveness of pipe inspection and reinforcement through the wrapping method. The inspection plan for gas pipelines that use the in-line inspection method is recommended to be one year from the date of the risk-based inspection assessment, which is every four years.

The confidence level is used for code 4 because it lacks accurate data, implying that the existing data is unreliable [19]. According to the table above, the inspection interval is four years.
